Long-term evaluation of the conservation state of marble statues

Abstract

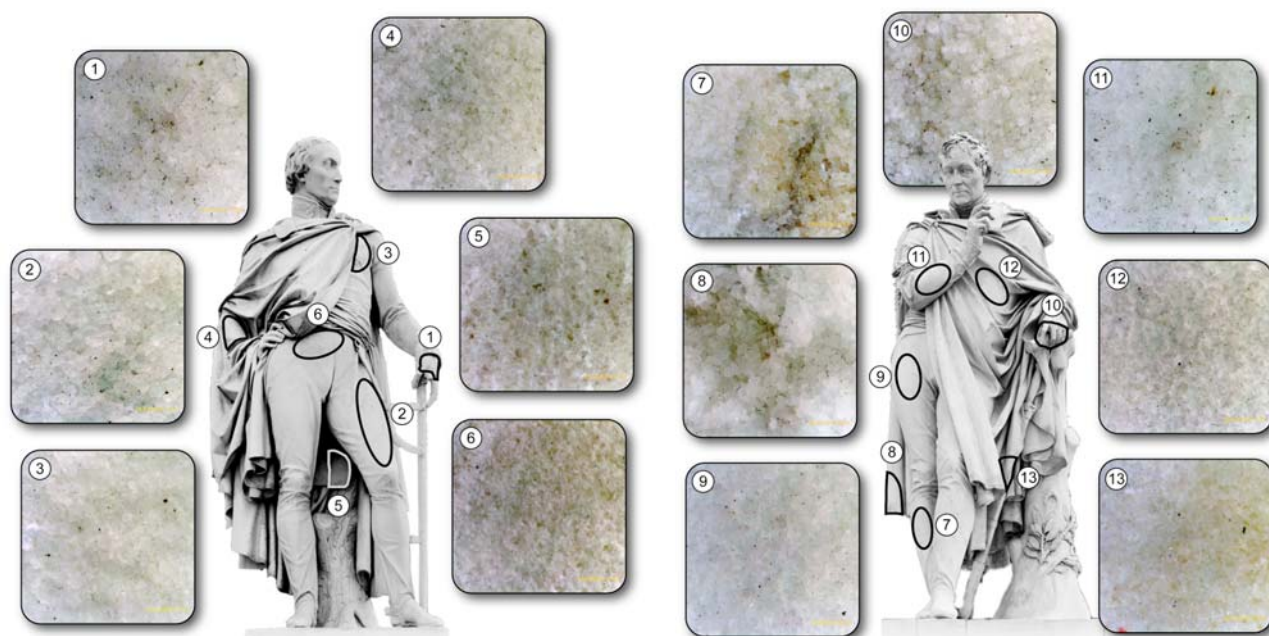
Both sculptures show similar forms of weathering. These include the crumbling of crystals, disintegration, relief formation, and discoloration combined with microbial growth (Fig. 2). The different forms of weathering were mapped during the first monitoring campaign in 2009 by restorer E. Böhme and a conservation action plan developed in 2013. Some of the damage to the surface can be traced back to the unsuitable cleaning campaign in 2005. In general the weathering of marble is caused by hygrothermal stress, solution decomposition, and frost bursting (Rüdrich 2003).

Figure 2. The surfaces of both marble statues show different conditions: 1) separation of crystals and formation of a relief, 2) weathered surface showing single crystals and a low relief formation, 3) moderate weathering, 4) moderate weathered area with microbial growth, 5) and 6) low weathered, nearly intact area with dirt deposits, 7) and 8) strongly back-weathered area with microbial growth, 9) moderately damaged surface, 10) separation of crystals by weathering and formation of a relief, 11) moderately weathered area, 12) nearly intact area, and 13) weathered surface.

The surface hardness ranges between 291 and 564 HLD. Most values of surface hardness of the tested areas (1, 3, 5, and 6) show a good correlation with ultrasonic velocity (Fig. 4), and therefore indicate a penetrative lost of strength also related to surface weathering. The measurements of areas 2 and 4 with around 350 HLD show quite low values of surface hardness but an ample ultrasonic velocity of on average nearly 4 km/s and a classification of II following Köhler. This area of the original surface is well protected against direct wind and rain but the crystal structure is weathered (Fig. 2 [2,4], 4).

The results of investigation have consequences for conservation, because only the strongly weathered areas can be treated by conventional methods. To ensure that a consolidation material is able to penetrate into areas with a damage class of III or II, vacuum impregnation methods have to be used.

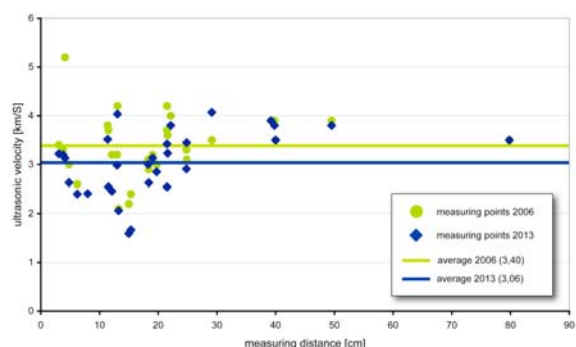
The results of ultrasonic velocity measurements in 2006 showed values between 2,1 km/s and 4,1 km/s. The average value of all measurements is 3,40 km/s. In contrast to 2006, the measurements in 2013 showed values ranging between only 1,6 km/s and a maximum of 4 km/s. The average value reached 3,06 km/s, which amounts to a reduction of 11%. A clear reduction of the ultrasonic velocity could be detected for sections with a material diameter smaller than 20 cm (Fig. 3). Most notable is the change of the ultrasonic velocity of the pommel of the sword. This pommel was replaced during the restoration in 2005. In 2006 a value of more than 5 km/s could be measured. Seven years later only 3,13 km/s was detected, which amounts to a reduction of around 40%.

Figure 3. The ultrasonic velocity related to the distance of measurement.

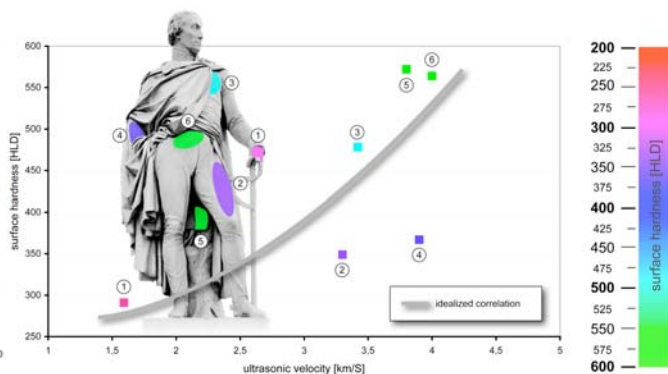
Capillary water absorption, tested by Karsten test pipes only could be detected for area 1. This area has had the lowest HLD values (291) and as well the lowest ultrasonic velocity (1.6 km/s), which means it reached nearly the classification I (disintegration).

Figure 4. The surface hardness correlated with the ultrasonic velocity.

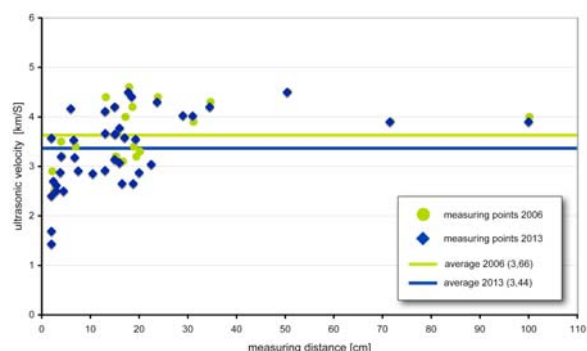
In a first campaign the sculptures were measured by ultrasonic velocity in 2006 after the last restoration. The sculpture show values between 2,5 km/s and 4,6 km/s and are reaching a average of 3,66 km/s. By the comparative measurements in 2013 values between 1,4 km/s and 4,4 km/s and an average value of 3,4 km/s could be detected. This comparative low weakening of the average value amounts to a reduction of 9%.

The highest values between 4,0 km/s and 4,6 km/s could be detected at compact areas such as the trunk of the sculpture. In 2006 as well in 2013 low ultrasonic velocity between 3,0 km/s and 4,4 km/s could be measured on free weathered arms and legs. Following the classification of Koehler, these areas are increasingly porous (II). The lowest values could be detected at filigree details such as fingers and robe folds. In 2006 these areas reached an average value of only 2,5 km/s. In 2013 an average value of only 1,7 km/s could be measured for these areas. The results show clear reduction of the ultrasonic velocity for sections with a material diameter smaller than 30cm (Fig. 5). This may be due to a deeper penetrative weathering that developed in the case of the Scharnhorst sculpture, probably because the sculpture was exposed to weathering 27 years longer than the Bülow sculpture.

Figure 5. The ultrasonic velocity related to the distance of measurement.

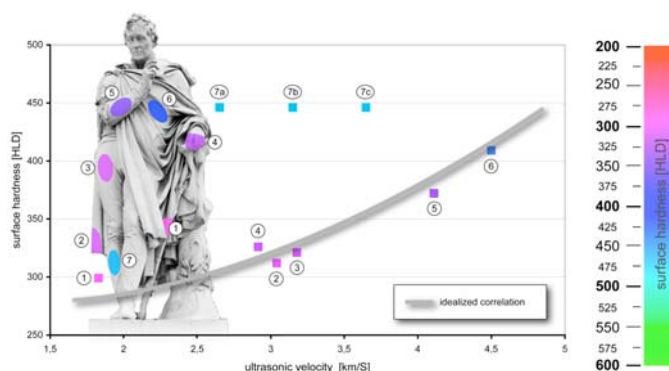
Surface hardness varies between 300 and 450 HLD. Nearly all values of surface hardness measurements show a good correlation with the ultrasonic velocity (Fig. 6). This indicates a relation of the lost of structural and surface strength and supports the thesis of a penetrative structural weathering. Only the measurements of area 7 with around 450 HLD show high values of surface hardness but only a medium-sized ultrasonic average velocity of 3.1 km/s. This area of the original surface is water-proofed and still in good condition while the ultrasonic value indicates that a structural weathering has also affected the area.

Capillary water absorption, evaluated by Karsten test pipes could only be detected in area 1. This area has the lowest HLD values (300) and the lowest ultrasonic velocity (1.8 km/s), reaching the classification IV (fragile) following Koehler (Fig. 6, Tab. 1).

Figure 6. The surface hardness correlated with the ultrasonic velocity.

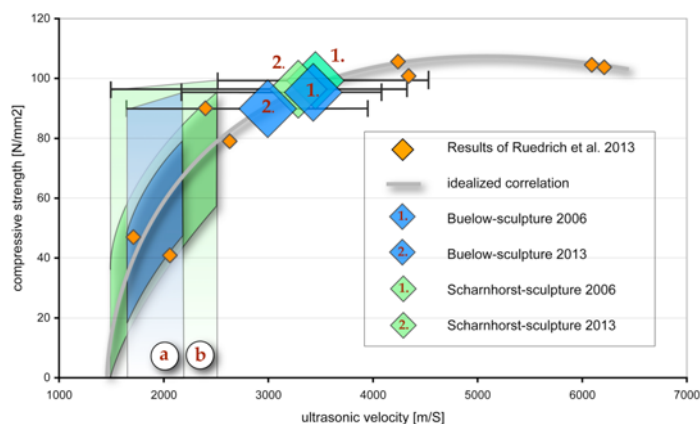
For the investigated samples of Carrara marble in different conditions, in a comparison of samples from both sculptures a compressive strength of 40.89 N/mm² for weathered samples and of 105.52 N/mm² for non-weathered ones could be detected (Rüdrich et al. 2013). In the cited study the authors also presented a clear correlation between ultrasonic velocity and compressive strength. By fitting the measured values of the ultrasonic velocity into the diagram of Rüdrich et al. 2013, the average compressive strength of the Bülow sculpture can be determined to be around 95 N/mm² in 2006 and 90 N/mm² in 2013. The changes become clearer when looking at the results for filigree parts of the sculpture. For these areas a reduction by half up to a maximum of around 60 N/mm² and a minimum of around 30 N/mm² can be assumed (Fig 7[a]). For the Scharnhorst sculpture it looks quite similar: the average value reaches around 100 N/mm² in 2006 and 95 N/mm² in 2013 but the affected filigree details of the sculpture show a reduction even higher than the for the Bülow sculpture (Fig 7[b]). Possibly this can be traced back to its sustained period of outdoor exposure over a period of 27 years. The Scharnhorst sculpture was exposed to weathering for 117 years, the Bülow sculpture for 90 years.

Figure 7. The results of the ultrasonic measurements inserted into the diagram of Rüdrich et al. 2013. The average values of the Bülow sculpture show lower ultrasonic velocity but a lower decrease of stability loss a) than the Scharnhorst-sculpture, b).

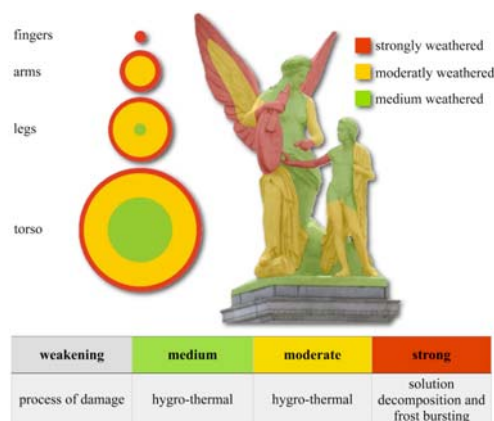
The reduction of compressive strength and loss of material stability seems to be concentrated on the parts with a low material thickness and was presented already as a model as one result of a scientific project to evaluate the state of conservation of the marble statues on the castle bridge in Berlin (Fig. 8; Rieffel 2010). The same weathering forms could be observed in the case of the measuring result of both sculptures in this study.

Figure 8. Model of the loss of stability dependent on the object geometry.
