Sgraffito in Israel

Case Study – Conservation and Restoration of Sgraffito at Mishmar-Ha'Emek Kibbutz

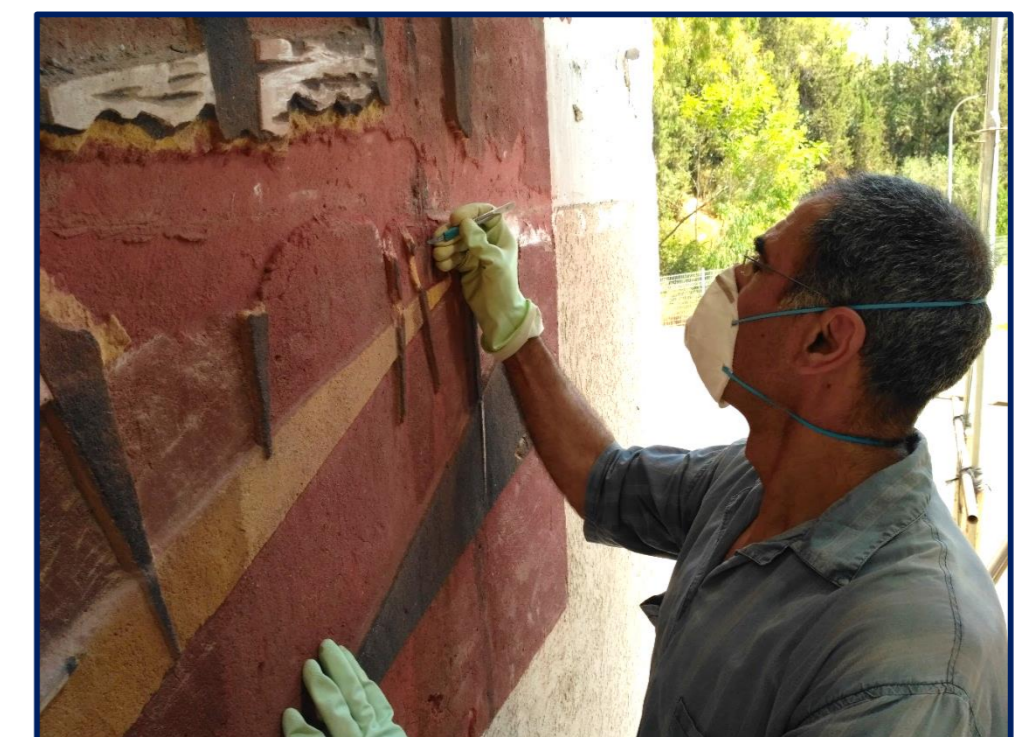
Cleaning the surface of the Sgraffito

The project begun with cleaning the surface from concrete and dirt drops, than stabilizing and pasting loose parts with Ledan. The conservation and restoration part of the project included completion of parts of the damaged work, while maintaining the layers of plaster, according to the color and thickness of the original work. Restoration of missing elements was carried out by referring to old photos of the sgraffito. At the end of the project, the conservers sprayed the Sgraffito with waterglass (Sodium silicate) and finished by retouching the art to create color uniformity with Keim colors.

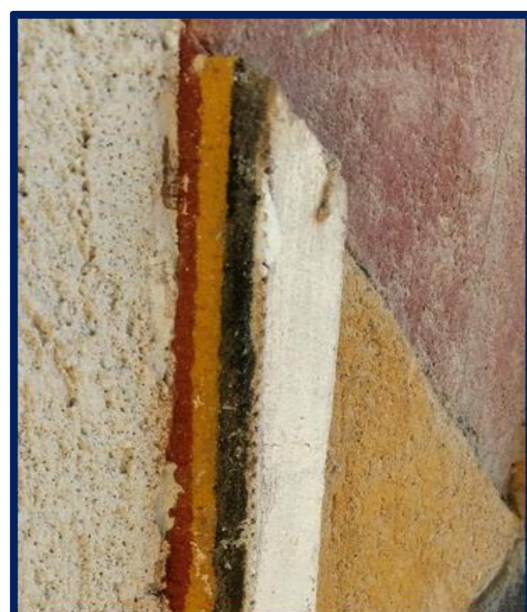
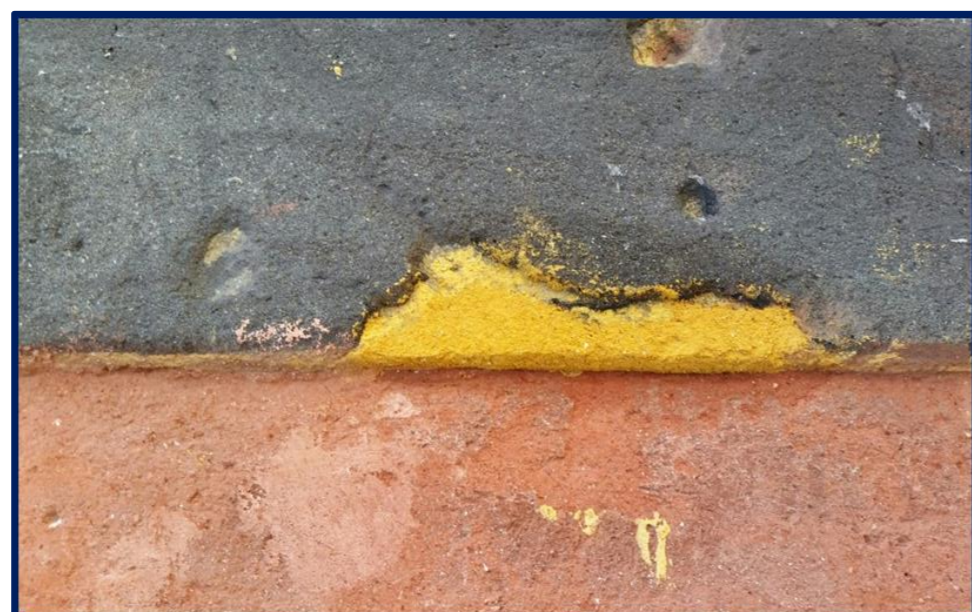
Maintaining the original layers of the Sgraffito

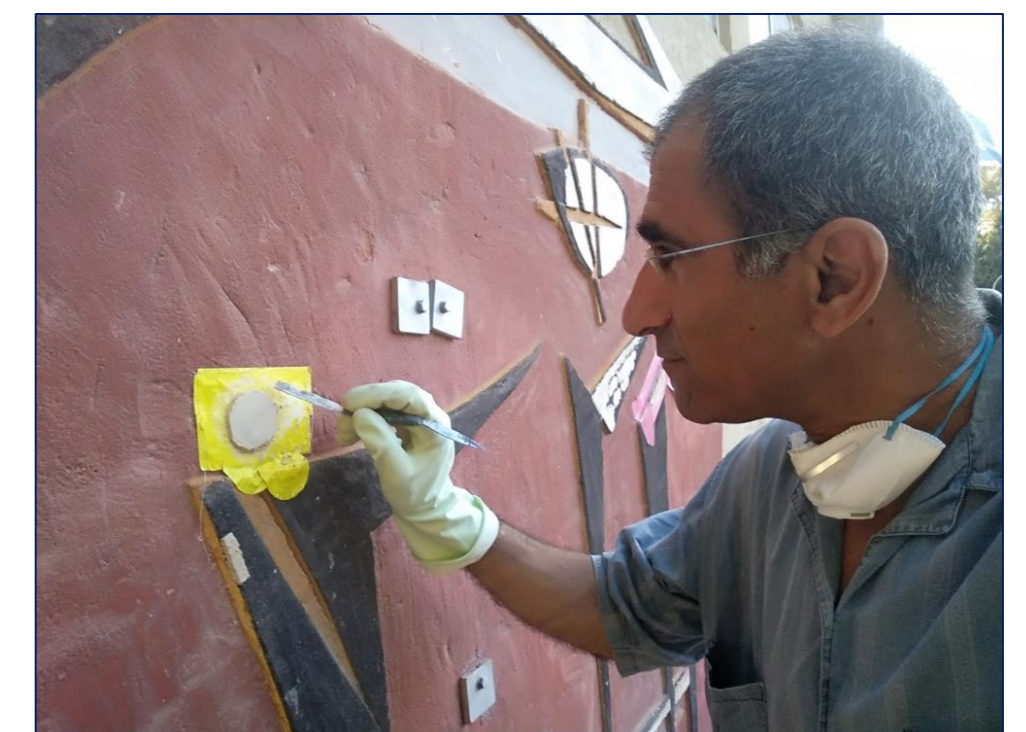
Restoration of missing elements was according to old photos of the Sgraffito

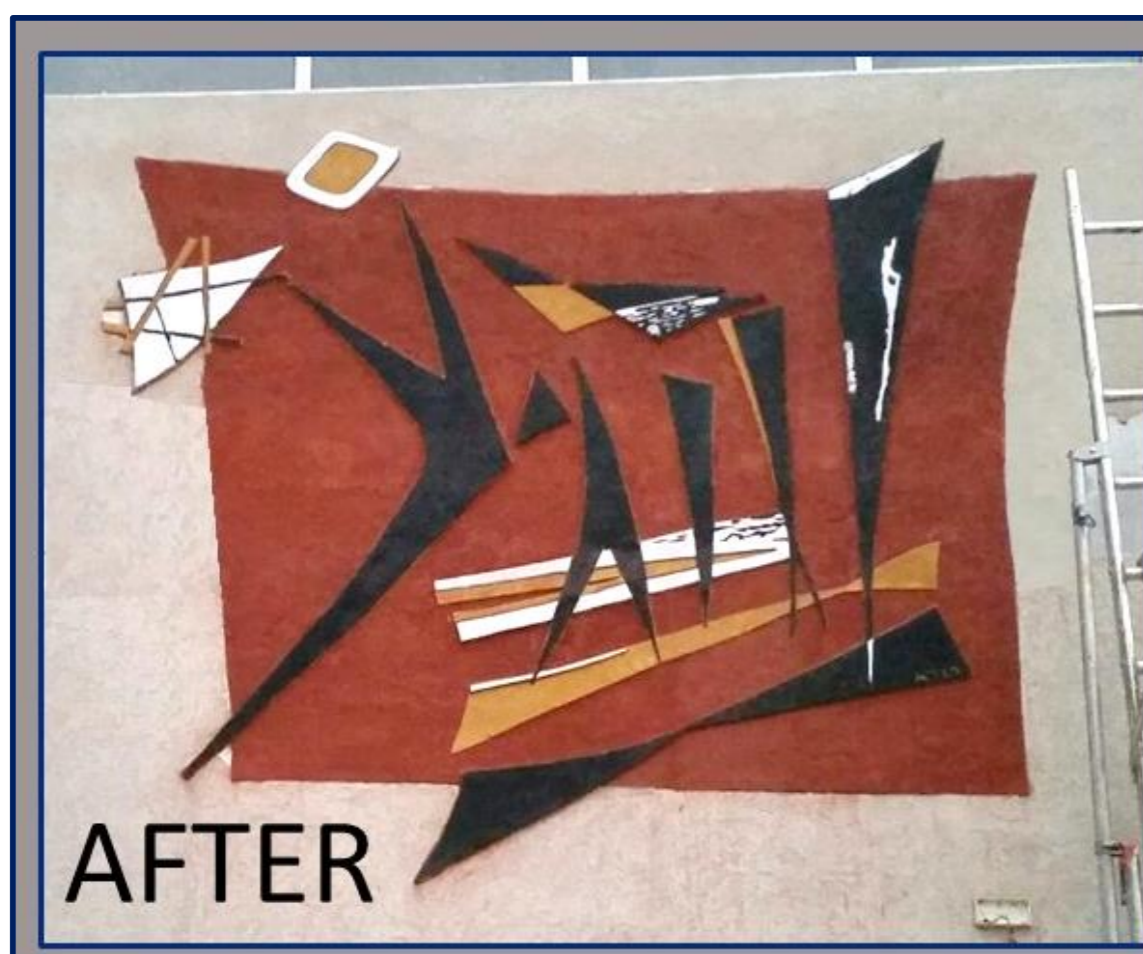
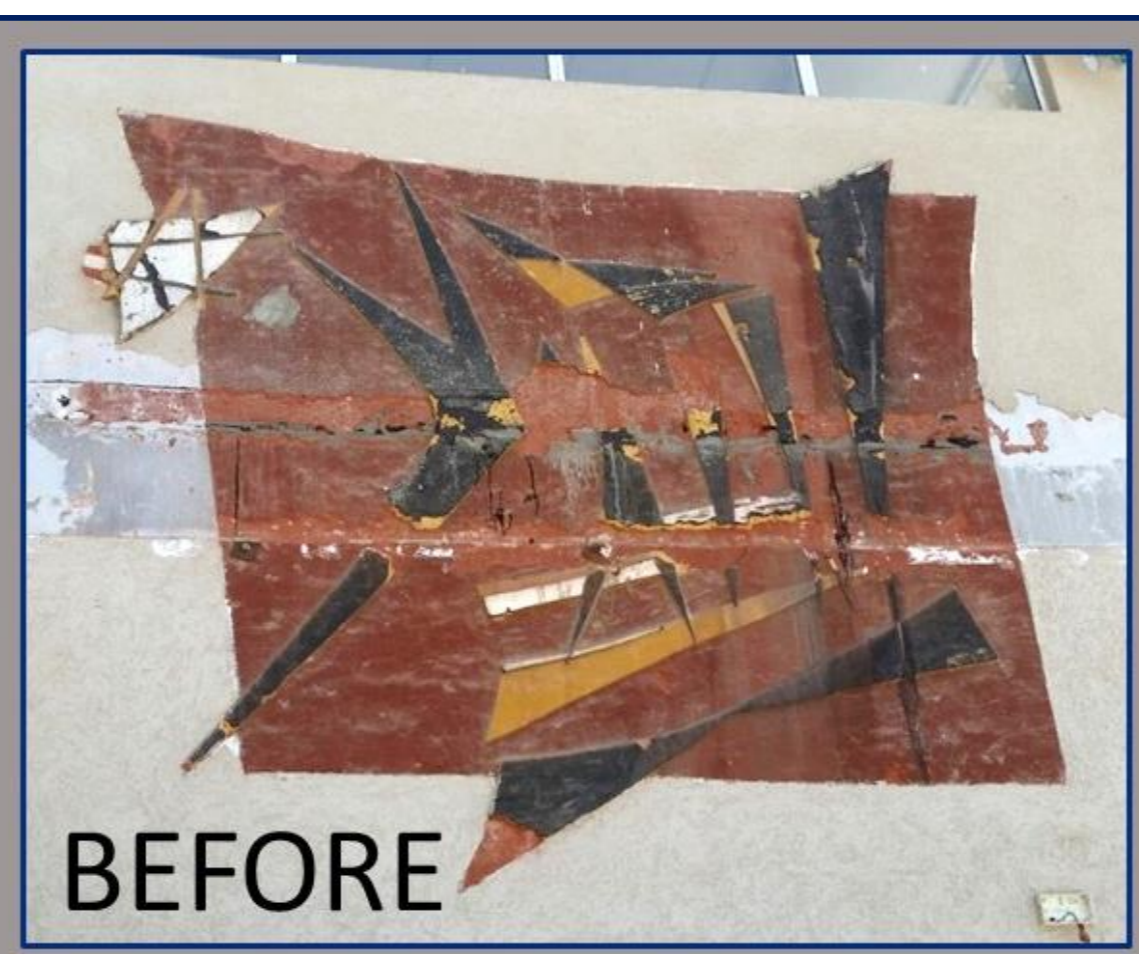
During June 2017 a conservation team from "Tchelet" Studio was working at a kibbutz in the north part of Israel, on a conservation project of a sgraffito work of art. The sgraffito was created in 1950 by a German artist - Ruda Ralinger, who was a member of the kibbutz. Over the years the sgraffito was damaged, mainly because of negligence and lack of awareness.

A photo of the Sgraffito before and after the conservation project.
