The white cubes haven't been white.

Conservators of the HAWK University of Applied Sciences and Arts in Hildesheim are investigating the facades of the Tugendhat House in Brno

IVO HAMMER

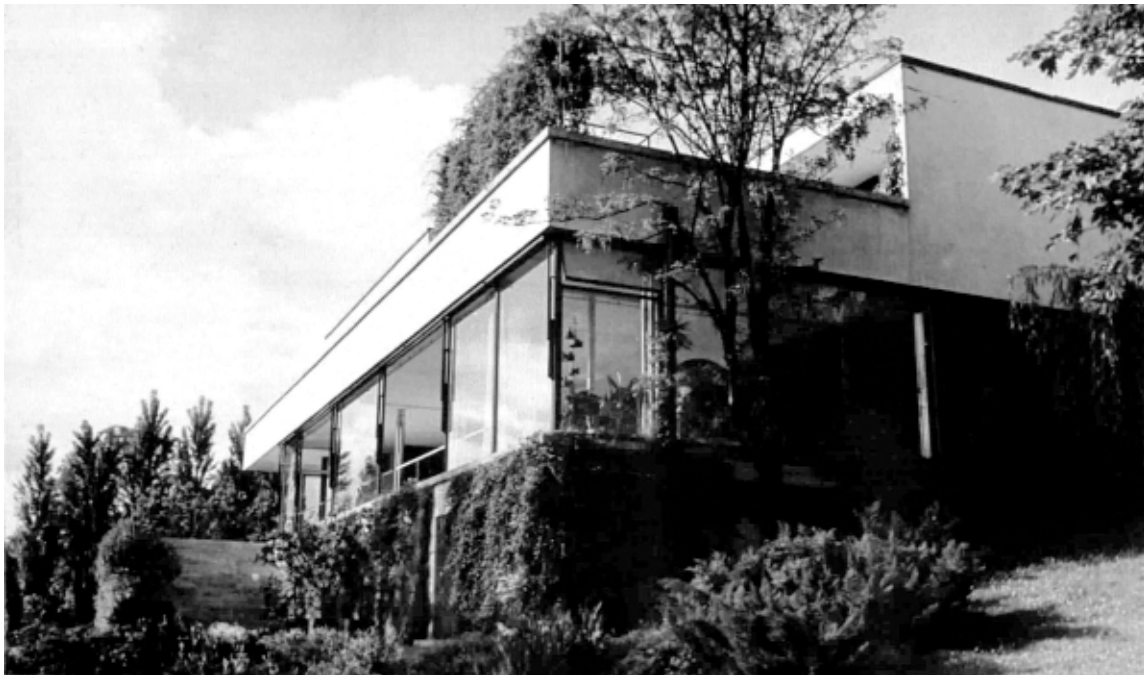
Brno, Tugendhat House, 1928-1930, Ludwig Mies van der Rohe. The lush vegetation on the facades is part of the artistic conception of Mies van der Rohe, aiming to a visual continuum between interior and exterior space. Photo Fritz Tugendhat, arr. 1934.

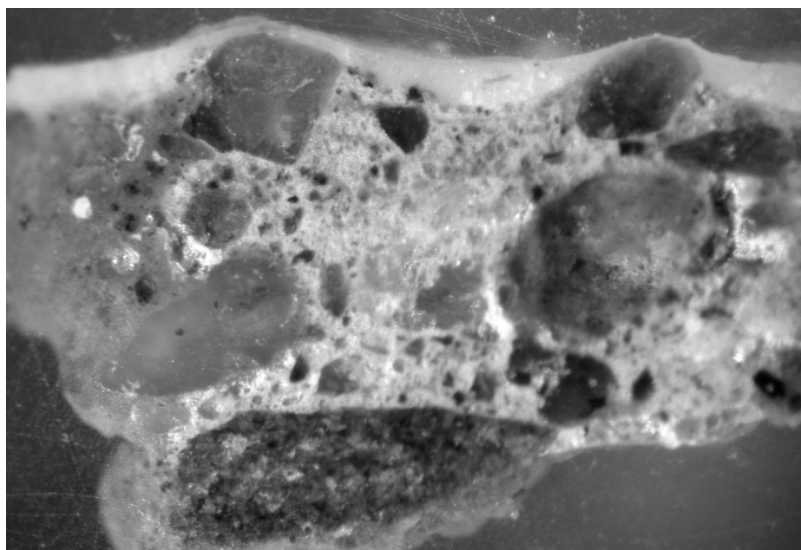
Brno, Tugendhat House, 1928-1930, Ludwig Mies van der Rohe. Cross section of the render of the facade dating from 1930. Photo HAWK, Christine Hitzler 2003.

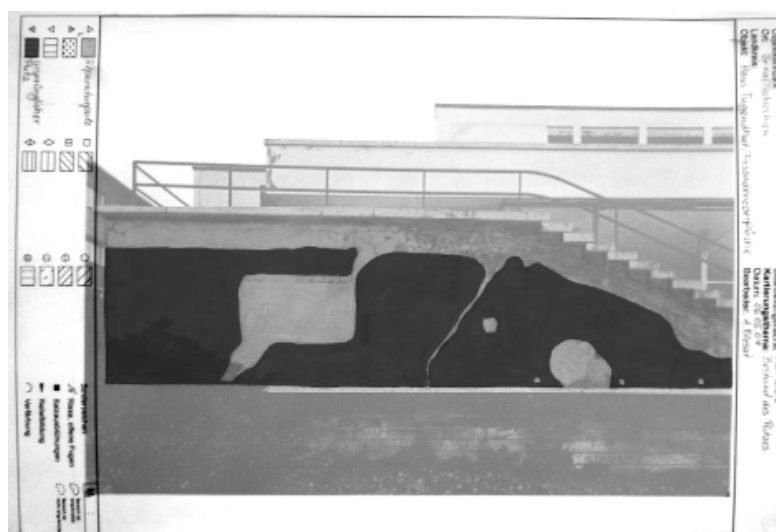
Brno, Tugendhat House, 1928-1930, Ludwig Mies van der Rohe. Map of the southern wall of the staircase. The historical fabric of the rendering of the facade (symbolized in red) is still preserved in substantial parts. Photo HAWK, Anneli Ellesat 2004.

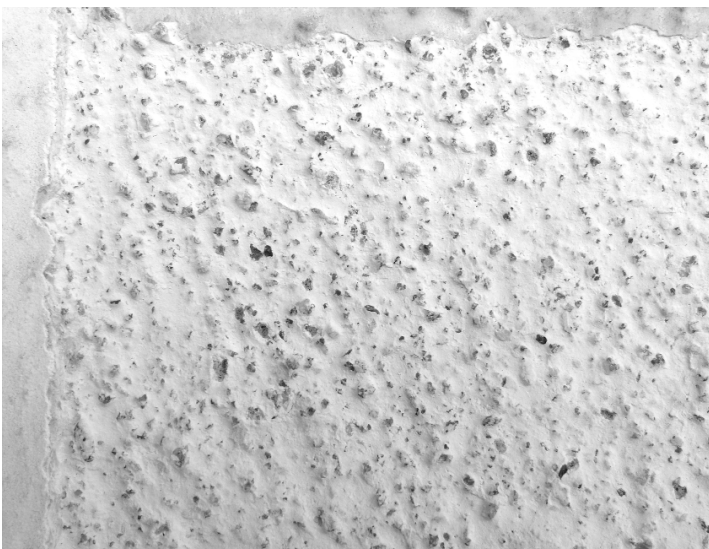
Brno, Tugendhat House, 1928-1930, Ludwig Mies van der Rohe, southwest facade, upper terrace, wall of boys sleeping room, detail, after cleaning 2004. The surface appears in a stone like colour. The rendering consisting of hydraulic lime mortar is smoothed with a wooden board. The yellowish lime paint is applied in such a manner, that the grains of the sand in the mortar appeared at the surface and were part of the polychrome. The thin paint contributed to the refining of the materiality of the surface.

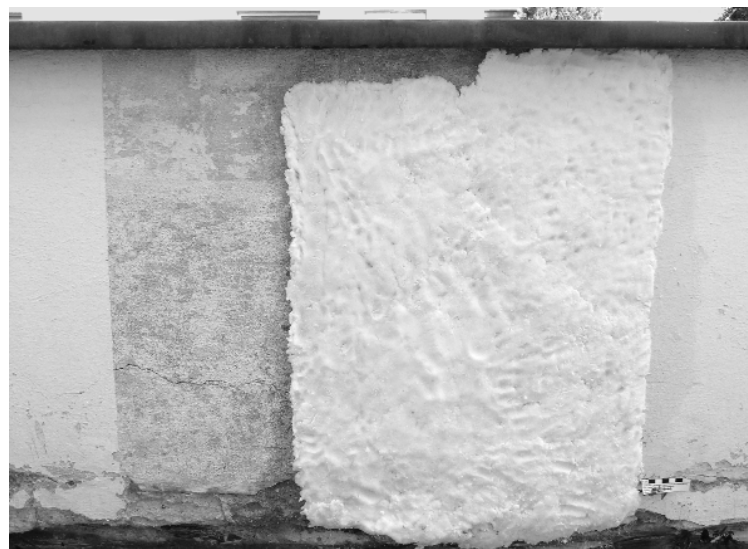
Brno, Tugendhat House, 1928-30, Ludwig Mies van der Rohe, northwest facade, parapet, southeast side, May 2004: Chemical conversion of the sulphated original surface of the rendering and compresses to diminish the soluble salts concentrated at the surface. Photo HAWK, Ivo Hammer.

At the same time technical methods of cleaning and conservation are tested, as are methods of sustainable maintenance. The methods applied do not differ from methods of conservation of wall paintings. To treat the sulphate crust procedures are used which have been developed and tested in Florence, e.g. in the conservation for the famous wall paintings of Masaccio (1426-1428) in the Brancacci chapel of the church del Carmine.

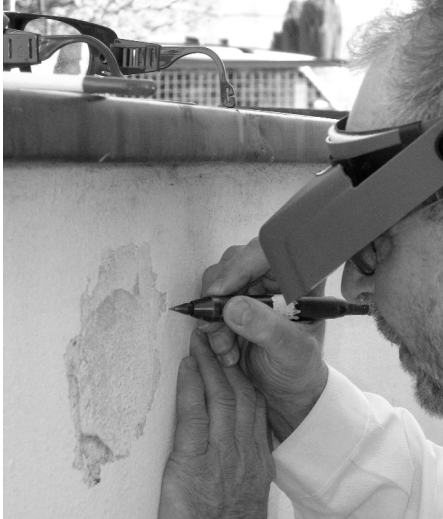
Brno, Tugendhat House, 1828-30, Ludwig Mies van der Rohe, northwest facade, parapet, south-east side, May 2004: First tests using pneumatic scissile to a careful detachment of the harmful coating consisting of cement grout and paint with artificial resin dating from 1985. Photo HAWK, Christine Hitzler.

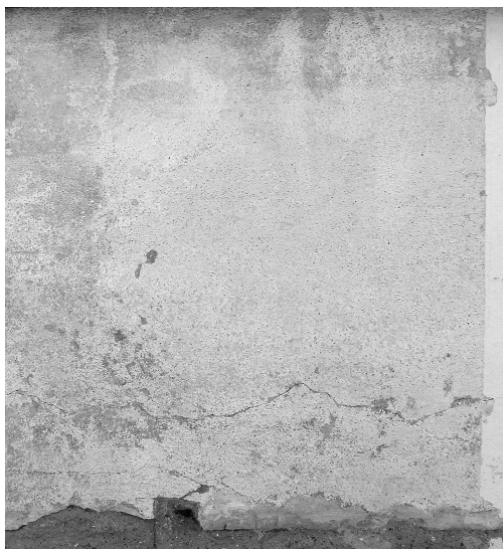
Brno, Tugendhat House, 1828-30, Ludwig Mies van der Rohe, northwest facade, parapet, southeast side, May 2004: Effect of chemical cleaning. After the conversion of the gypsum the appearance of the surface is much brighter, but not white. Photo HAWK, Ivo Hammer.

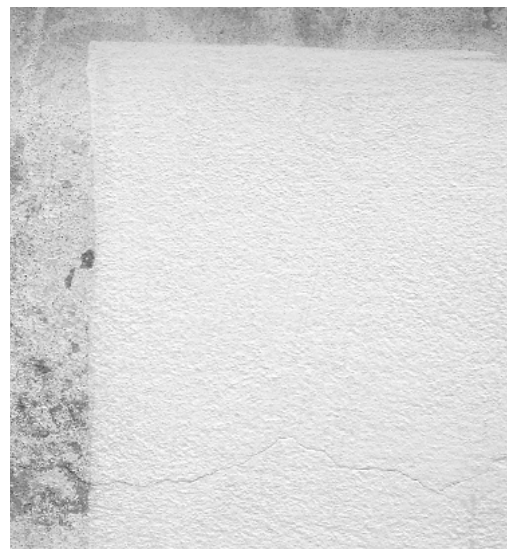
Brno, Tugendhat House, 1828-1830, Ludwig Mies van der Rohe, northwest facade, parapet, southeast side, May 2004: First test of a thin lime wash coloured with fine suspension of local sand. This coloured lime wash takes over the original technique of surface coating and may be seen not only as protection of the original surface but also as a technique of sustainable maintenance. Photo HAWK, Ivo Hammer.
